**CARL SANDBURG HOME NATIONAL HISTORIC SITE
CULTURAL LANDSCAPE REPORT**

DECEMBER 1993

Susan Hart
School of Environmental Design
University of Georgia

Prepared for Carl Sandburg Home National Historic Site
in cooperation with the Cultural Resources Planning Division,
Southeast Regional Office, National Park Service, Department of the Interior

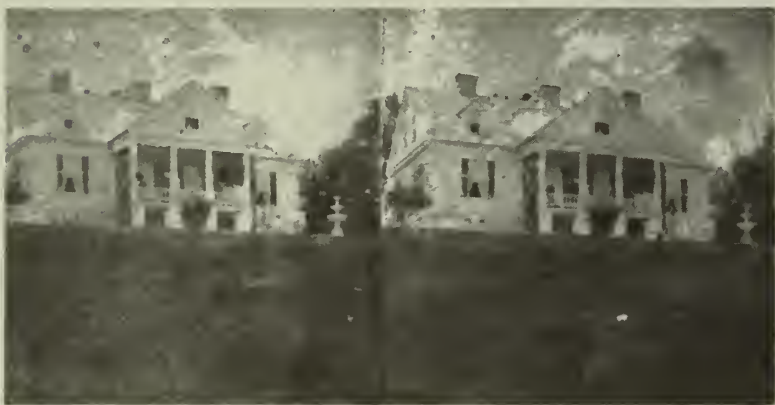
Figure 2.4 Steriopticon of Rock Hill, c. 1880
Photographic Archives, #28466

The earliest photograph of the house, a stereopticon photo, c. 1880, provides a view of the north side including the lawn and formal fountain, see Fig. 2.4 (Photo Archives, CARL). The spring-fed fountain was installed in 1852 (Bailey 1980, 18; C. G. Memminger Papers; Frazier and Paige 1981, 11; Patton 1961). The absence of front steps and the side porch, which later enclosed the Sandburg greenhouse, is conspicuous here. There appears to be no foundation plantings either. References in the Memminger Papers at the Southern Historical Collection at the University of North Carolina, Chapel Hill, date the front lawn to as early as 1853.

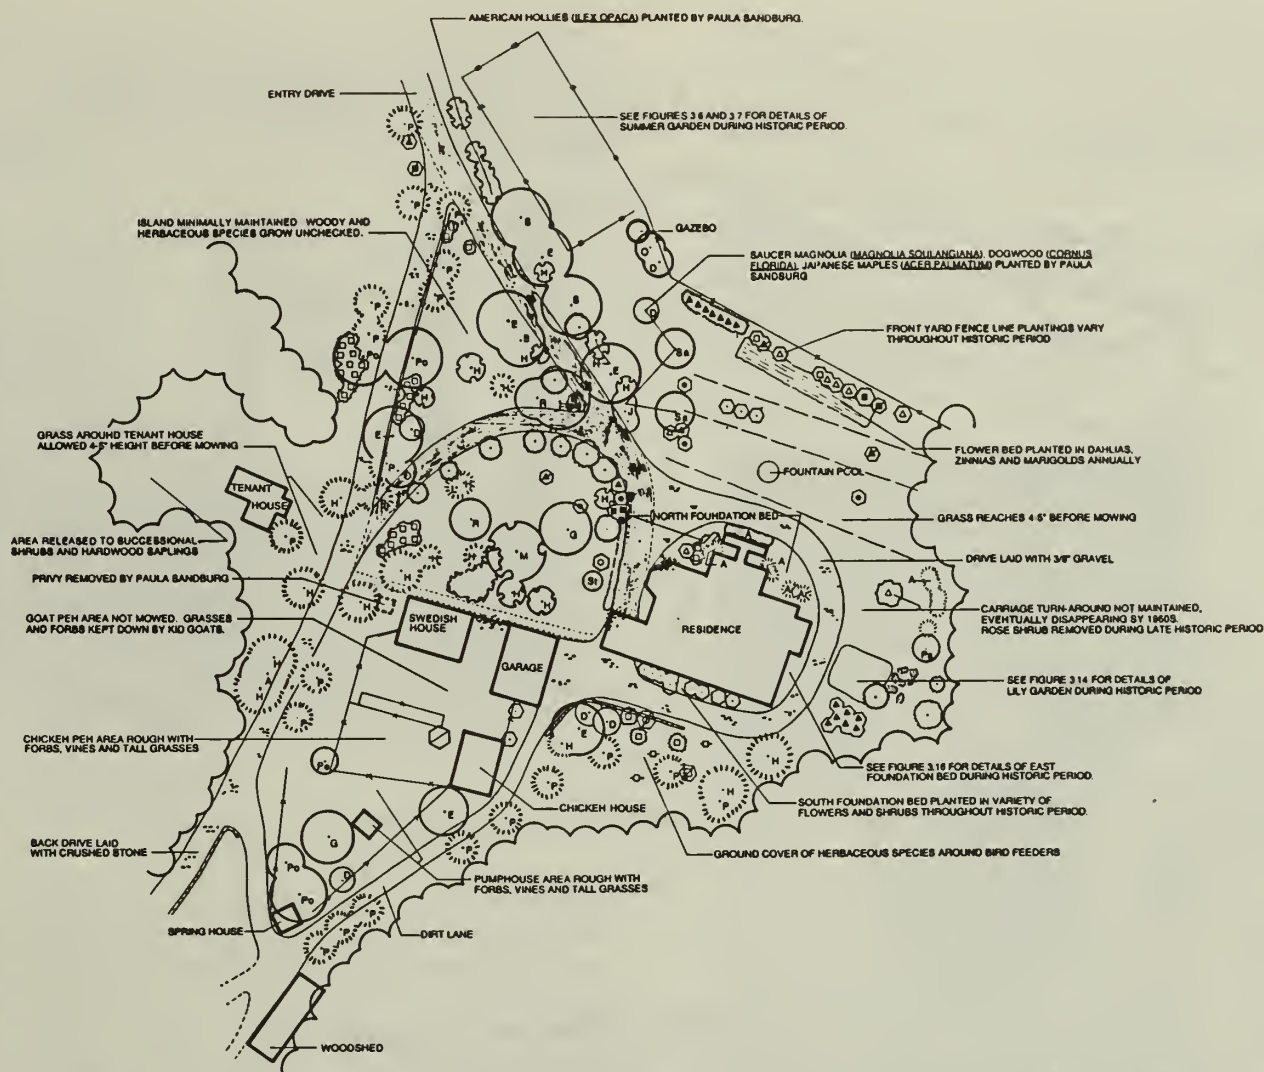
NOTES: DRAWING REPRESENTS LATE SANDBURG PERIOD (C. 1963)

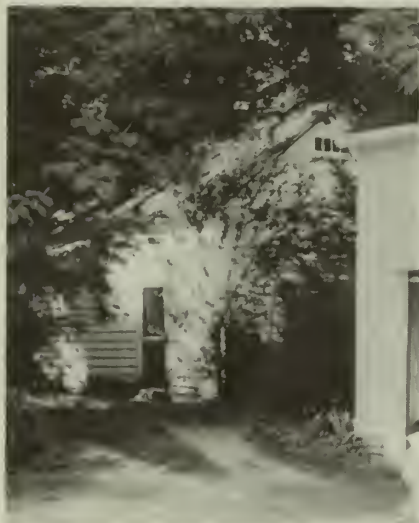
Figure 3.22 Garage Corner and Chicken House, c. 1965
Photographic Archives, #87-1

Late photographs (mid-1960s) indicate plantings of rose-of-sharon, a small mimosa tree, and an evergreen (possibly a spruce) just outside the gate to the goat pen. Irises and ferns grew on the garage's southeast corner, see figure 3.22 (Photo Archives, CARL).

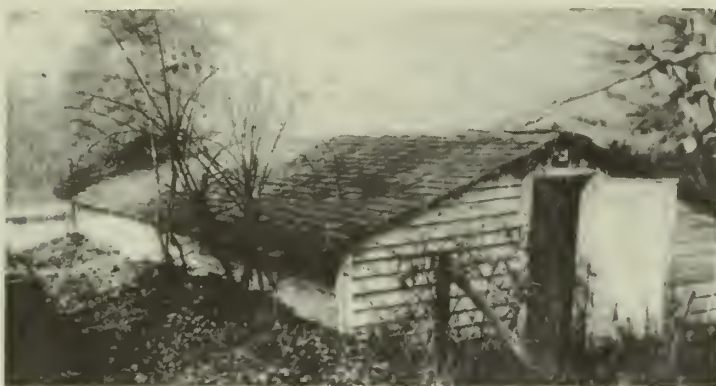
Figure 3.25 Green House, c. 1950
Photographic Archives, #389-1

SPRING GARDEN (figure 3.24)--The green house, or root cellar, located in this area was not used much by the Sandburgs and fell into disrepair during their time at Connemara (figure 3.25). The nearby water storage tank was used by the Sandburgs. It is not known if they or the Smyths had it installed.

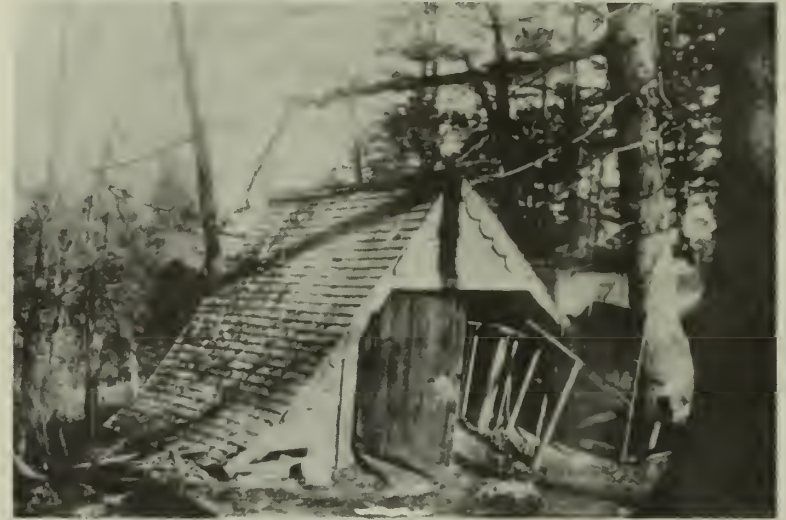
Figure 3.29 Ice House, c. 1947
Photographic Archives, #391-1

Southeast of the house stood the ice house, in poor shape by 1945. It was removed by 1950; however, the pit was not filled until the NPS period, see figure 3.29 (Polega in Photo Archives, CARL). Other nearby structures included: the chicken house and pen, a woodshed, and a buck house farther to the north.

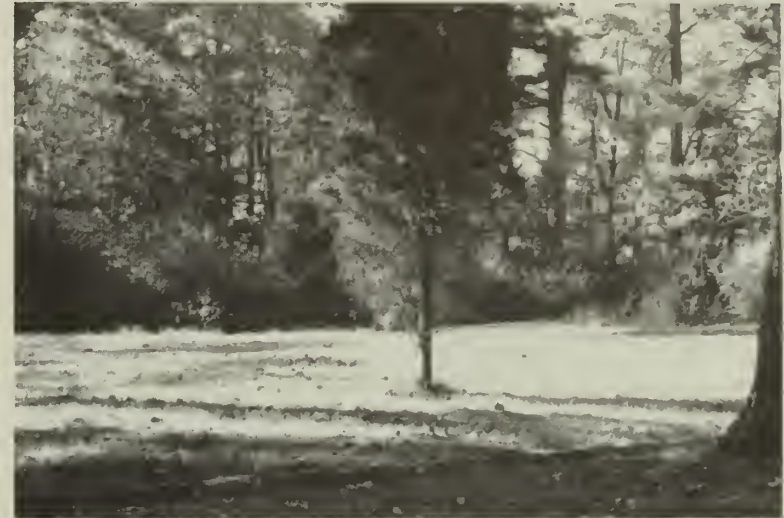
Figure 4.3 Rock Outcrop near Upper Entry Drive, 1990
Photograph by author

The rock outcrop area across from the summer garden was cleared of all existing successional species during the 1970s (Hamn 1989). The fence alongside this part of the entrance drive was removed, and the historic drainage ditches were reconstructed in 1979 (Ward 1989). The area

is now kept in grass and mowed every two weeks in summer (figure 4.3).

Compromises to feeling are found in present management techniques, which result in a cleaner and more polished entry drive. Vegetation is managed more carefully than in the Sandburg period, a policy most evident in the treatment of forbs, grasses, and vines. Fallen branches and leaves are removed from the drive's edges, and the rock outcrop area along the upper entry drive is maintained by mowing every two weeks in the summer.

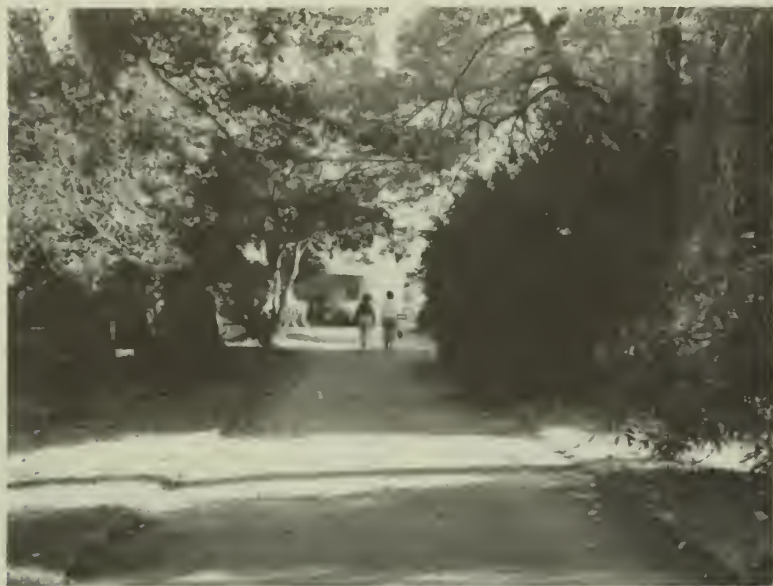
Figure 4.4 Upper Entry Drive near Residence, 1990
Photograph by author

The upper entry drive closest to the house retains much of its historic vegetation (figure 4.4). The American hollies, American elms, Japanese maples, and remaining boxwood continue to contribute to the setting of the Sandburg home. Treatment of this area consists of keeping ground covers clear of debris and the grass mowed often, again resulting in a clean park-like setting.

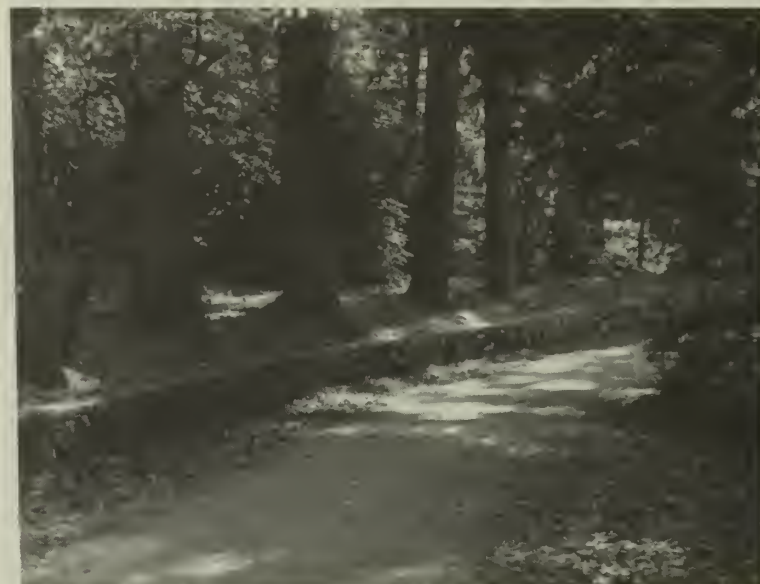
Figure 4.5 Back Drive Leading to Barn, 1990
Photograph by author

BACK DRIVE TO BARN AREA (figure 4.5)--The loss of white pine and other large trees lining this part of the back drive has continued since 1969. Several hemlock and white pine were removed in front of the tenant house and across the drive near the Swedish house (Hamn 1989; Photo Archives, CARL). Reasons for their removal are unknown, however,

the protection of historic structures was probably the motivation. Several dogwood trees have contracted the anthracnose fungus. Selected ones are sprayed with a benomyl solution periodically to counteract effects.

The boxwood hedge and retaining wall are important features of the Sandburg landscape. Maintenance of the wall involves only minor repairs. However, the western most part of the wall, beyond the boxwood to the entrance lane of the vegetable garden, appears to be of NPS construction.

Boxwood along the retaining wall are not trimmed, resulting in the loose, shrubby character typical of the historic period. Forbs and grasses along the drive edges are mowed often, and fall leaves are removed from the drive. Crushed stone is relaid every two to three years.

The feeling associated with this part of the back drive is somewhat compromised because of the loss of large conifers that once stood near the tenant house and Swedish house. In addition, present management policies do not allow for the growth of weeds and other forbs along the edges of the drive, but keep them closely cropped and neat. None of the untidiness indicative of the Sandburgs's management is observed.

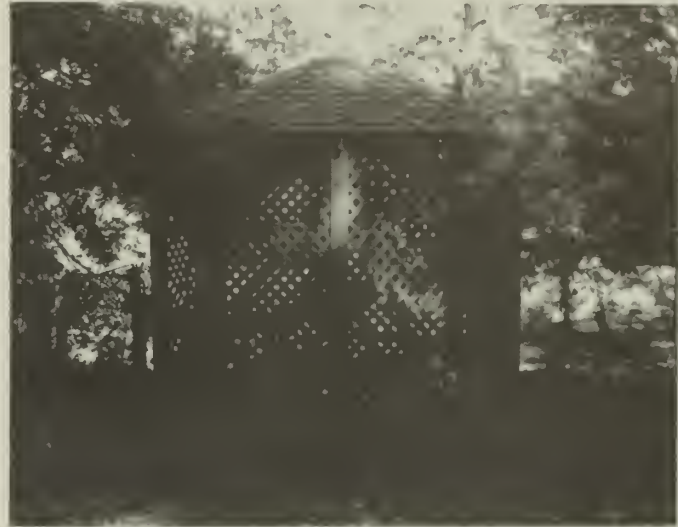
Figure 4.6 Summer House near Summer Garden, 1990
Photograph by author

SUMMER GARDEN--The location of the summer garden has not changed from Sandburg days, and the enclosing chain link fence is historic. Fencing on the pasture side was removed and replaced with metal posts and woven wire. It is not known if metal posts were used during the Sandburg period. The setting of this garden has changed because of the loss of large white pines in and near the garden entrance, although dates of their demise are unknown. The summer house, or gazebo, was restored by the NPS (figure 4.6).

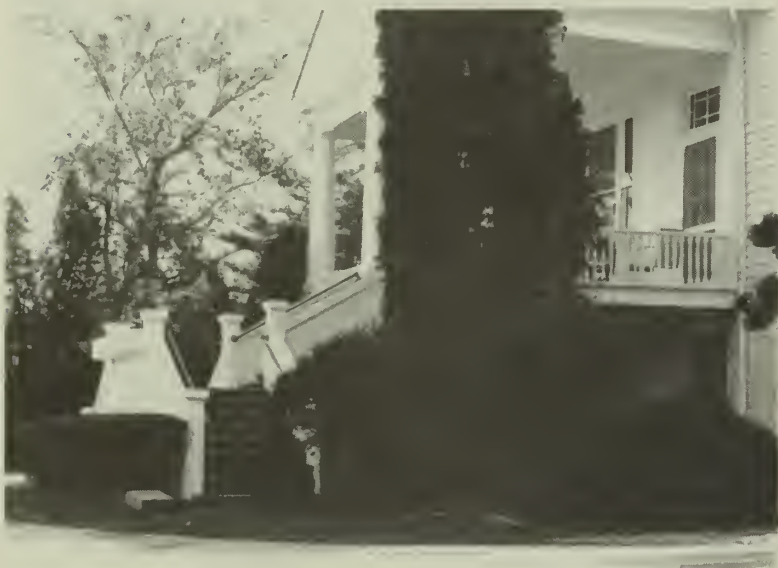
Figure 4.7 North Foundation Plantings, 1990
Photograph by author

MAIN HOUSE, NORTH SIDE--Integrity is strengthened here by the existence of much of the historic vegetation, and the survival in their original locations of fences, the fountain pool, and the drive around the house. Foundation plantings consist of many overgrown plants. Azaleas, rhododendron, and conical arborvitae are now taller and leggier than they were during the historic period. In contrast, the bridalwreath spirea and abelia are pruned and kept smaller and neater than they were historically, see figure 4.7 (Ducker 1989).

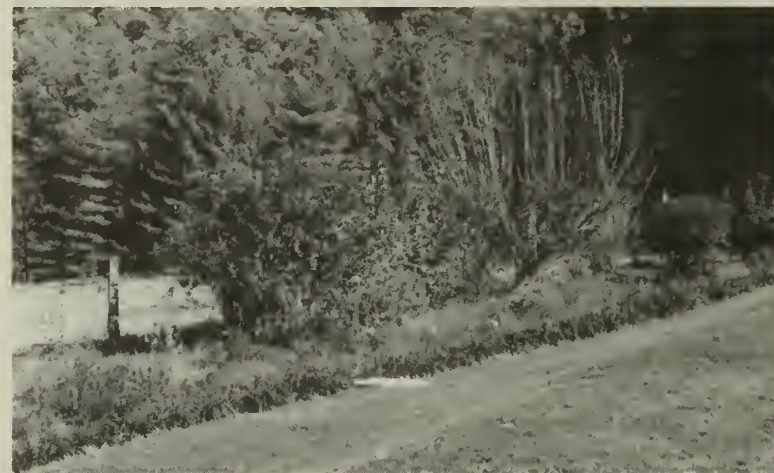
Figure 4.8 Front Lawn Showing Part of Dahlia/Zinnia Bed and Fence Line Plantings, 1990. Photograph by author.

was restored by NPS, whose personnel plant dahlias, zinnias, and marigolds annually. Plant materials are bought locally, see figure 4.8 (Freeman 1990).

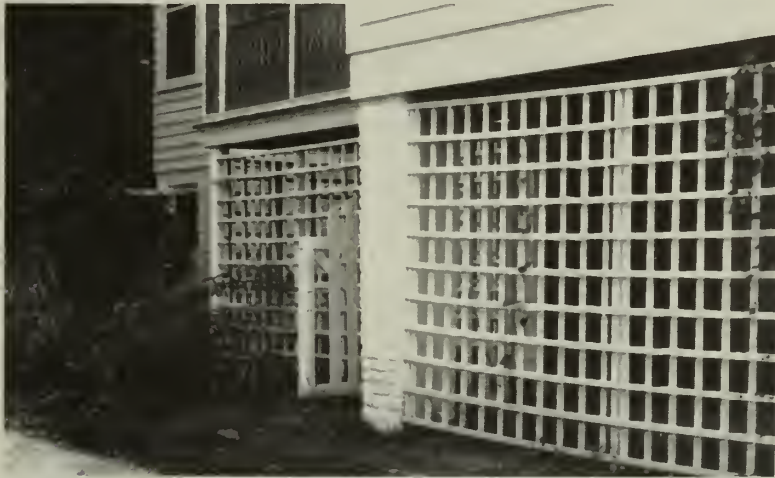
Figure 4.9 East Foundation Bed, 1990
Photograph by author

Other existing historic vegetation includes the arc of columnar arborvitae defining the location of the carriage turnaround. Foundation plantings have diminished to only a few nandinas, an acuba, iris, aster (possibly *A. Tataricus*), and wild potato vines (*Ipomea sp.*), see figure 4.9. The lily

Locations of flower beds, lawn edges, and most historic plant material are clearly defined here. Some compromises in integrity were made with the loss of plant material in the foundation bed and the lack of variety of color and bloom time in the lily bed. The insertion of an amphitheater and the removal of historic boxwood shrubs also diminish its integrity.

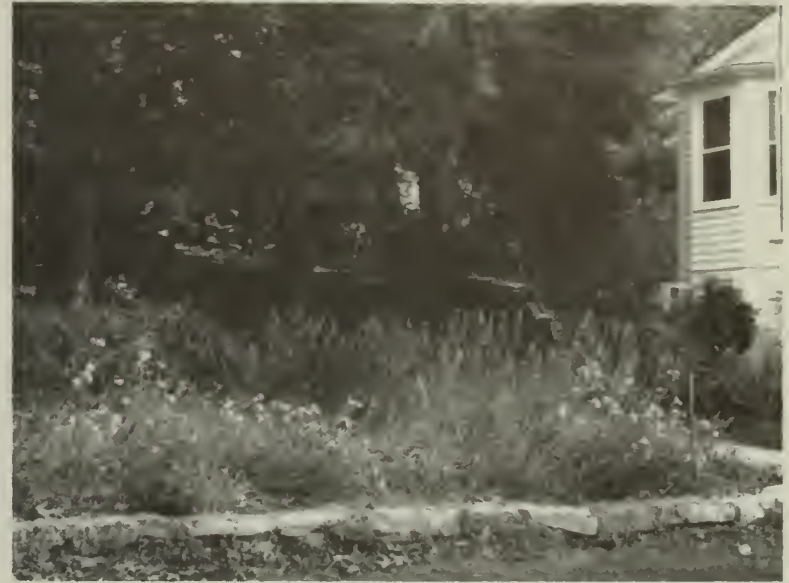
Figure 4.10 Lily Garden, 1990
Photograph by author

bed was partially restored by the NPS. Existing plant materials, however, do not provide continuous bloom and a variety of color throughout summer. Daylilies are the dominant planting, with some chrysanthemum, petunia, crocus, garden phlox, impatiens, cockscomb, marigolds, candytuft, Pacific Giant delphinium, and garden balsam. Lilies and Connecticut Yankee Blue delphiniums have not been added (figure 4.10).

One experiences Paula Sandburg's love of flowers to some degree with the existing lily bed. However, an appreciation of abundant overgrowth exemplified in the foundation bed

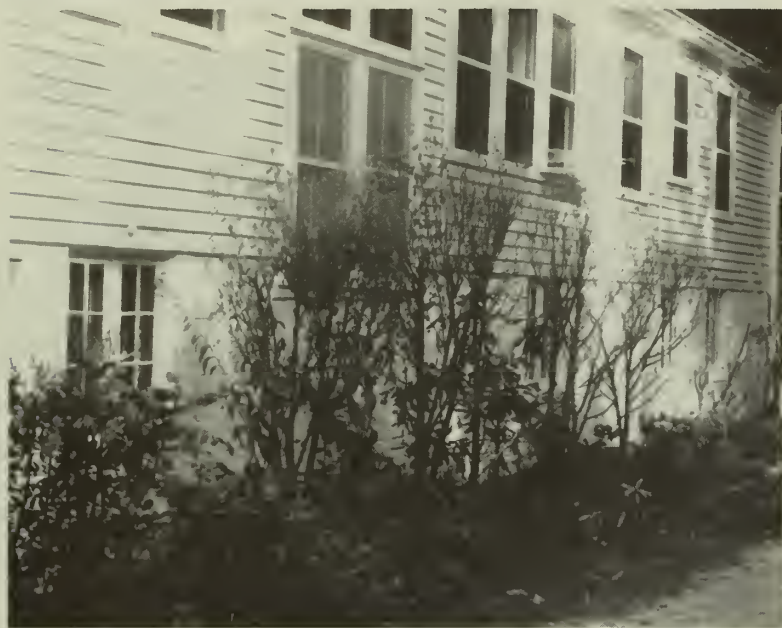
Figure 4.11 South Foundation Bed, 1990
Photograph by author

MAIN HOUSE, SOUTH SIDE--The foundation bed, retaining wall, bird feeders, and historic vegetation preserve the historic integrity of this side of the house. Foundation plantings consist of survivors of a late planting by Paula Sandburg, including rose-of-sharon, nandina, rhododendron, native azalea, mahonia, English ivy, leucojum, periwinkle, and daylilies. The other flowering perennials known to have been planted here died out. Management consists of light pruning and mowing to keep down weeds (figure 4.11).

Edges of the drive are mowed with the same frequency as the lawn; thus, the historic untidiness of taller grasses and

forbs here and above the retaining wall is absent. Only two freestanding bird feeders remain.

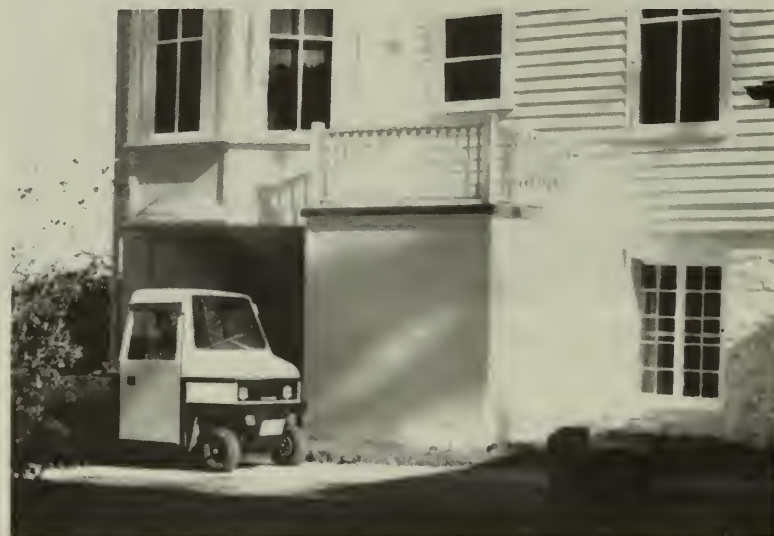
Figure 4.12 West Side of House and Carport, 1990
Photograph by author

MAIN HOUSE, WEST SIDE--Historic integrity has been preserved in this area west of the main house. Changes in character can be observed in the aging of some plant material, and some small losses of historic vegetation. For example, the star magnolia is declining, as is the southern magnolia, which fortunately has an offspring from a rooted branch. A tall white pine near the carport was removed. The ginkgo, American hollies, lilacs, hydrangea, flowering quince, forsythia, and nandina survived, and the large American boxwood shrubs rejuvenated after a severe pruning in the 1970s (Hamn 1989). The low box hedge (*Buxus sp.*) was removed from the edge of the drive. The trumpet vines were also removed when city water lines were laid into the house (figure 4.12).

Grass in the area is clipped every two weeks. The bamboo continues to confine itself to its historic boundaries. Hemlock nearby have matured, producing more shade than existed during the historic period.

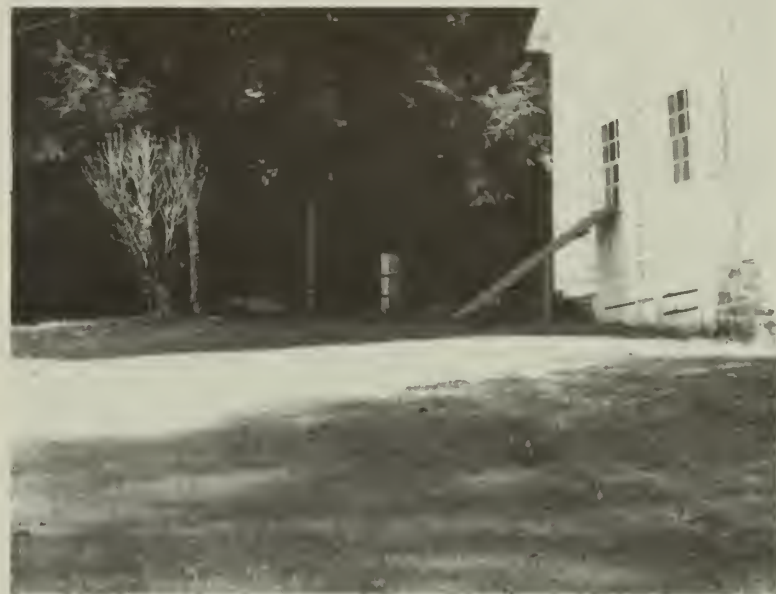
Figure 4.13 Kid Goat Pen, 1990
Photograph by author

Vegetation is managed in different ways. The goat/chicken pen is maintained by mowing twice a month in the summer, whereas the pump house area is allowed to become overgrown with woody and herbaceous species. Fences are treated differently--those surrounding the pump house pen are covered in Ipomea and honeysuckle, and those of the goat/chicken pen contain few or no vines (figure 4.13).

Double fencing at the kid goat gate was removed or replaced with single woven wire. Vegetation removed near

this gate includes rose-of-sharon and a small evergreen. The large viburnum inside the kid goat pen survives today; however, the tall pear immediately west of the chicken house died and was removed. Also lost was a trumpet vine on the fence between the garage and Swedish house (Hamn 1989).

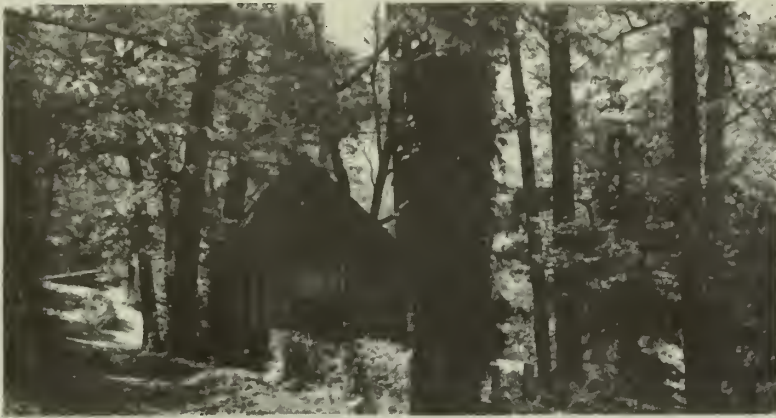
Figure 4.14 View of Spring House with Overgrown Area around Pump House to the right, 1990. Photograph by author.

The southern half of this area retains much of the typical character of the Sandburg landscape, overgrown and neglected. The feeling evoked from the sight of fences overgrown with vines and an unused pen rampant with weeds reinforces its integrity (figure 4.14). However, the kid goat/chicken pen area does not evoke the same feeling. A particularly damaging factor is the lack of vines on fences and the manicured "lawn" inside the pen.

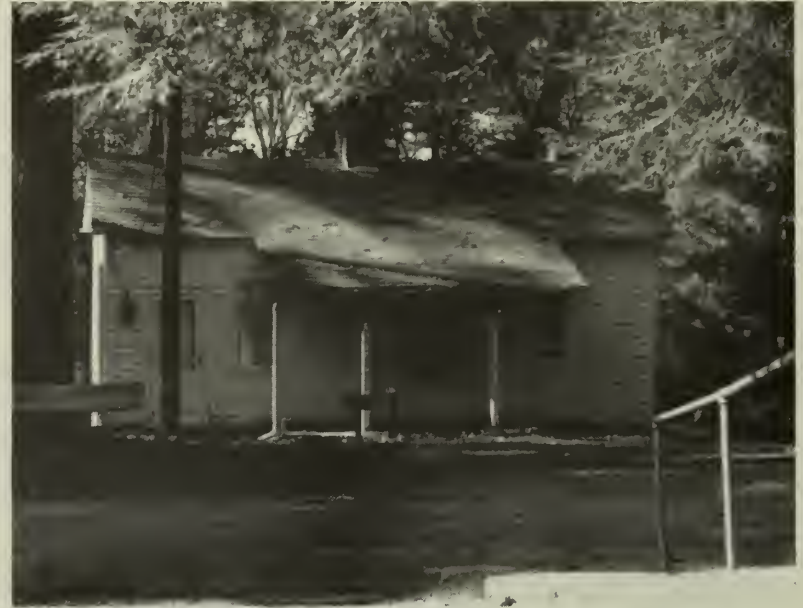
Figure 4.15 Tenant House, 1990
Photograph by author

TENANT HOUSE (figure 4.15)--The tenant house has received restoration treatment and presently contains the park's historic archives. It is not open to the public. The location of a temporary comfort station nearby introduced a non-compatible structure into the historic core area. Although partially screened by tall rhododendron, it still conspicuously greets visitors on their way to the barn area from the entry drive.

Because of the removal of several hemlock along the back drive, this area is now much sunnier than it was historically. Grass is mowed twice a month in the summer. South and east of the house, second growth hardwood trees continue to mature and shade the area between the tenant house and the farm manager's house.

Association with the historic scene was compromised with the intrusion of the comfort station. The loss of the large hemlocks and the lawn of cut grass diminish the feeling of the unpolished historic scene.

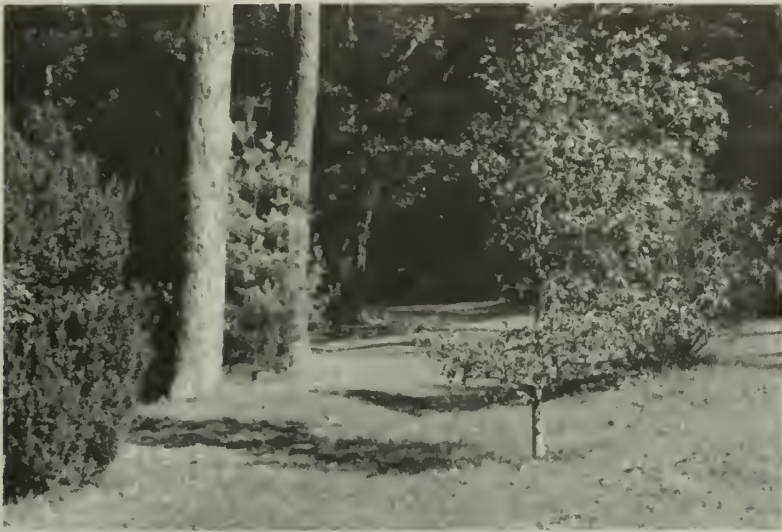
Figure 4.16 Spring Garden, 1990
Photograph by author

SPRING GARDEN (figure 4.16)--Very little remains of the spring garden area as experienced by the Sandburgs during the historic period. By 1970, the area was covered with successional shrubs and hardwood saplings. Because the Sandburgs had maintained only the "garden" area of flowering shrubs and bulbs--releasing all areas around it to natural successional growth--the area was, by 1970, well into early stages of second growth hardwood. By 1973, it had been completely cleared of successional growth, except for some flowering shrubs. Boxwood shrubs defining the doe burial ground were removed (aerial photos; Photo Archives, CARL). Presently, only one flowering quince and the boxwood lining the back drive remain. The spring garden is now grassed and mowed twice a month. Each spring only a few daffodils come up.

Historic buildings and structures in the area include the greenhouse, reconstructed in the 1970s, Helga Sandburg's beehives, and the Sandburg water storage tank. The NPS added three 1500-gallon water storage tanks to accommodate visitor demand (Hamn 1989; Weber 1989). What fencing remained during the Sandburg period was removed in the 1970s, and the wooden gate, removed during the Sandburg period, was replaced. Recently, the wooden posts of this gate fell into disrepair and were removed. No gate presently stands at this entrance to the spring garden.

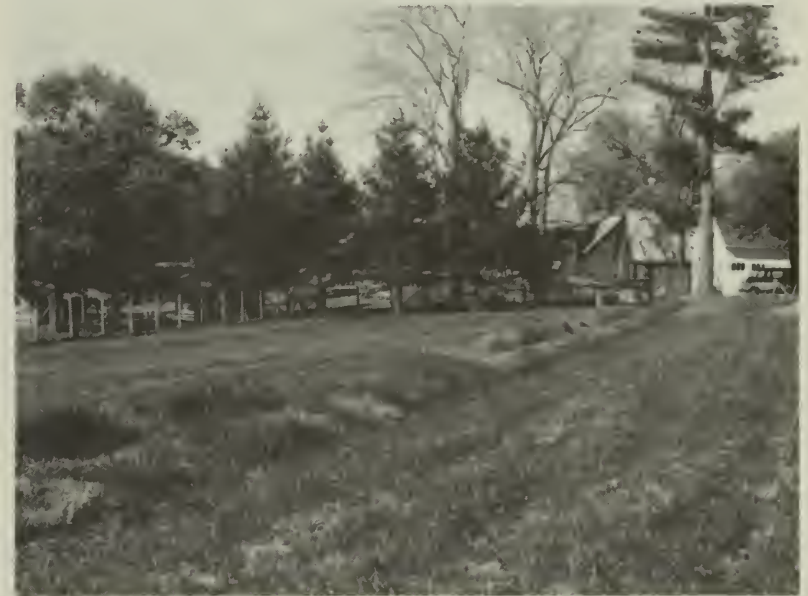
Figure 4.17 Vegetable Garden, 1990
Photograph taken from south edge by author

VEGETABLE GARDEN (figure 4.17)--Vegetable garden boundaries are clearly defined on three sides and have changed little. The NPS at one time allowed park personnel to manage their own vegetable plots, and all of the garden was planted (Weber 1989). Today a smaller garden, approximately twenty-five feet by seventy feet, is maintained, and produce is set out daily for visitors to take home. The existing tall fescue was put down in the 1970s and is mowed three or four times a year.

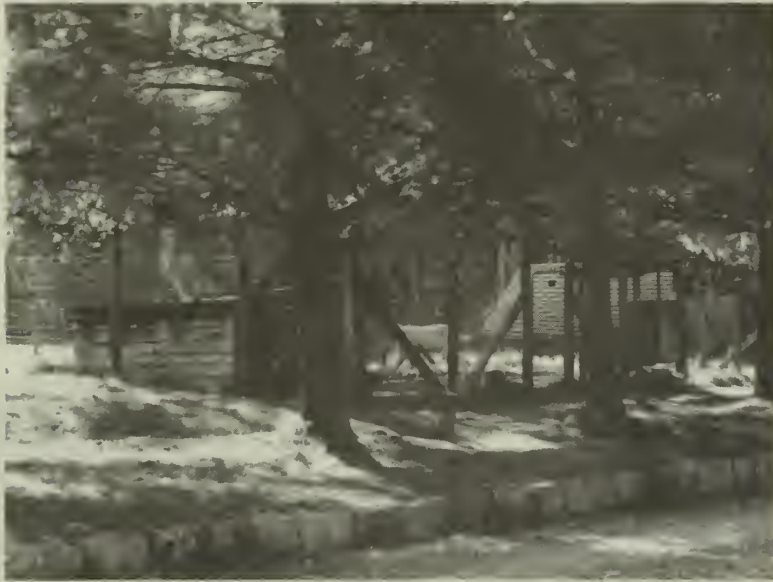
Figure 4.18 Buck Houses near Vegetable Garden, 1990
Photograph by author

Fences south and west of the garden and enclosing the buck pens survive in their original locations. Of the two small structures used as buck houses during the Sandburg

period, only one is used today (figure 4.18). Surviving vegetation from the historic period includes the Chinese quince, a large boxwood near the south edge, the Chinese chestnut, and an apple tree near the lane entrance.

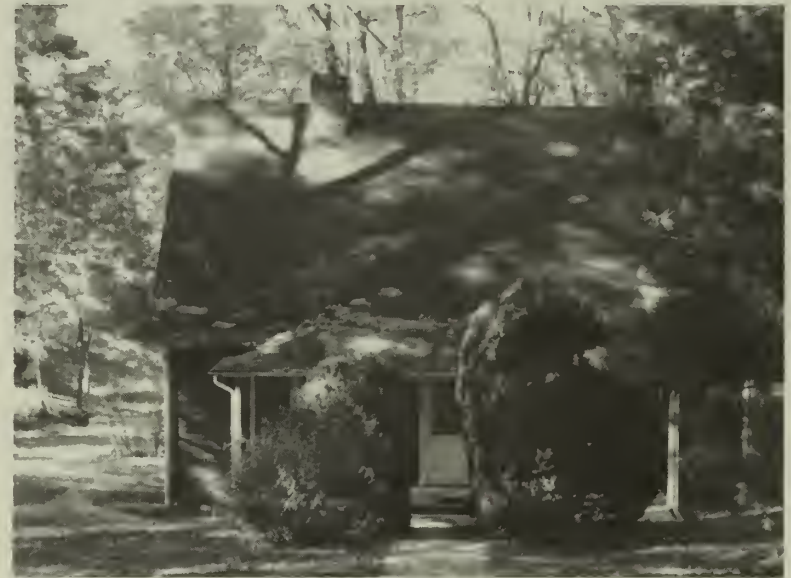
Figure 4.19 Farm Manager's House (Present Park Office), 1990
Photograph by author

FARM MANAGER'S HOUSE (figure 4.19)--The farm manager's house received restoration work in the 1970s and is presently used as the park office. To accommodate this new use, certain changes were necessary. These include a slate walkway, stone retaining walls and drainage ditches, and a ten car staff parking area.

Since 1970, the yard of the farm manager's house has undergone changes. Several small trees and shrubs were removed in a general "cleaning up" process. The surrounding canopy of hardwoods was altered with the complete clearing of an area immediately east and southeast of the house. This has resulted in a sunnier, more open look than existed historically. Recently, the NPS has

The loss of shade to the east of the farm manager's house diminishes the historic feeling of the area. The encroachment of second growth hardwood from the tenant house over to the ice pit was halted by replacement with grass. Again, the area has a clean, park-like setting not typical of the historic period.

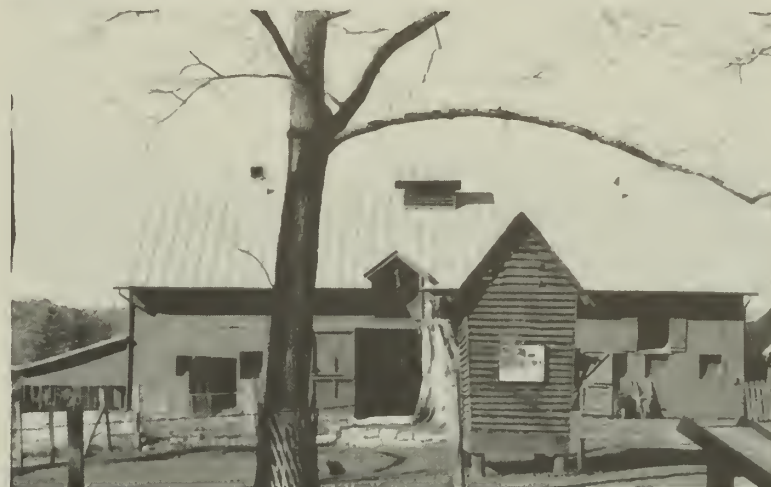
Figure 4.20 Goat Barn, 1990
Photograph by author

GOAT BARN (figure 4.20)--Many of the historic structures in the goat barn area received restoration work during the 1970s. No changes in the location of structures and fences is indicated, except for the removal of two salt blocks placed near the elm tree during the Sandburg years.

During the NPS period the use of some structures changed. This includes the cow shed now being used to house chickens. The horse stalls of the main barn are now used for storage of old equipment. The milk house is presently not used. The barn garage was used as a park maintenance facility as late as 1980 until a new facility was built near the back drive entrance. Today farm machinery

The NPS manages the grass in the barnyard and nearby pastures by keeping it shorter than it was during the historic period. The greatest change, however, occurred with the loss of the large American elm in front of the barn. The loss of this tree and the shade it provided has been significant. Today, existing walnut trees continue to shade the southern half of the barnyard. The small drive through the barnyard is maintained with periodical relaying of crushed white limestone.

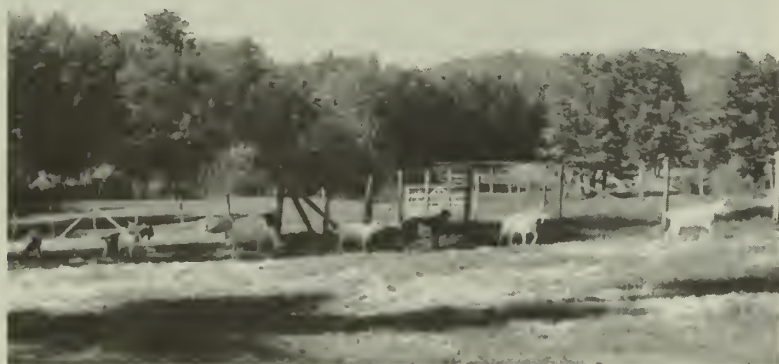
Figure 4.21 Descendants of Chikaming Herd, 1990
Photograph by author

The present policy consists of managing a smaller number of goats, approximately sixteen, and keeping only chickens and a few cats. Present interpretive programs for the goat barn includes brief tours with NPS staff, a milking demonstration, a cheese-making demonstration, and photographs and posters on the interior walls of the barn. Of the three breeds kept today at Connemara, only the Toggenburg and Nubian goats are Chikaming descendants. (figure 4.21)

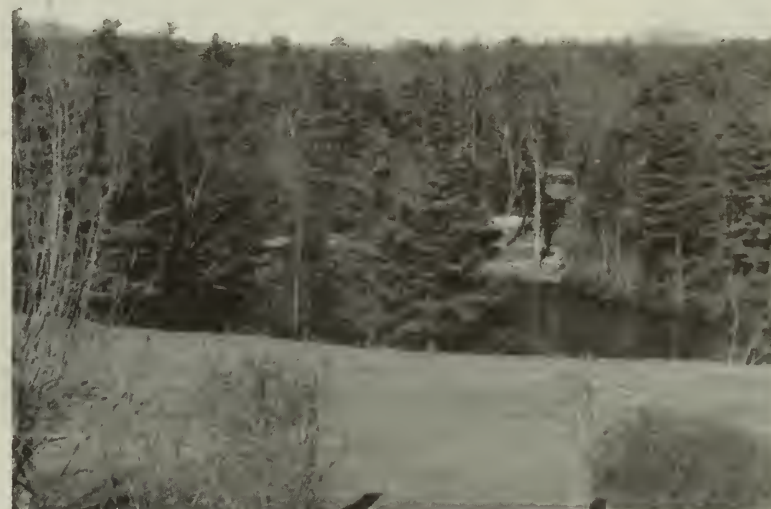
Figure 4.22 Front Pasture and Front Lake, 1991
Photograph by author

Front pasture today is leased for grazing. One or two horses remain in this pasture year-round, and the leasee agrees to mow and fertilize on a regular basis. Grasses consist of a mixture of fescue, orchard grass, and clover, although much of it has been crowded out. Some encroachment of woodlands from both the north and south edges of the lake have changed the eastern boundary of the pasture to some degree, see figure 4.22.

Integrity of front lake and pasture, however, is strong as existing vegetation, fence lines, and land use contribute to the feeling associated with the historic period. The lake, although cleaner, still retains much of its "neglected" character with the encroachment of shrubs and young trees along its edges and the reintroduction of waterlilies on the northern end.

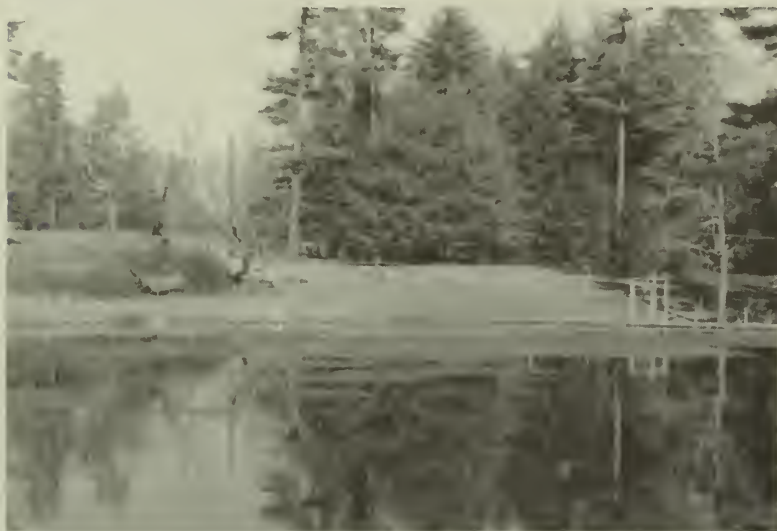
Figure 4.23 Side Lake, 1991
Photograph by author

Side Lake and Pastures--Restoration work was also completed at side lake and dam in the early 1980s. The dam was repaired for leakage, overgrown vegetation was removed, and the lake was dredged. In the winter of 1990, dredging was repeated. Today parrot-feather milfoil (*Myriophyllum* sp.) continues to invade the lake and must be kept in check on a regular basis (figure 4.23).

Most of the shrubby vegetation overgrowing the north bank from the 1970s was removed; however, large dead trees have been left for aesthetic purposes. On the south bank, the duck cage remains in its original location. The

Sandburg "beach" no longer shows evidence of sand, but the location is obvious.

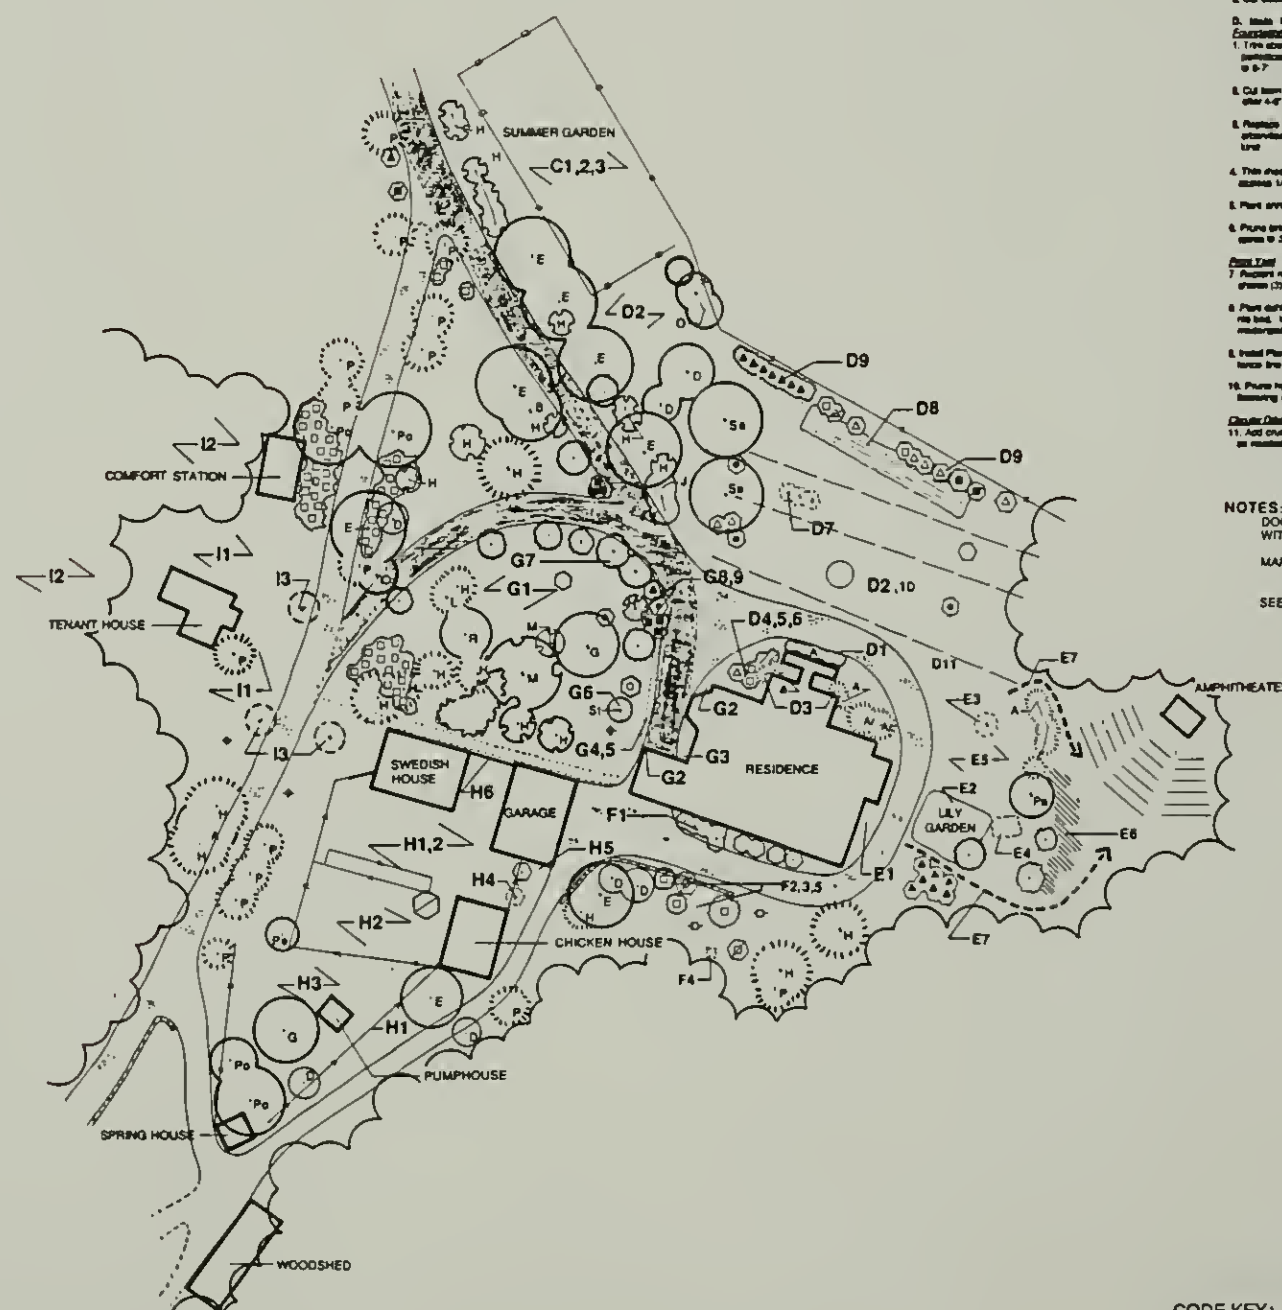
Figure 6.2--Residence Area--Management Recommendations

AREA
MANAGEMENT RECOMMENDATION

MANAGEMENT RECOMMENDATIONS DETAILED IN APPENDIX N

MAIN HOUSE, NORTH SIDE (figure 6.2)

MAIN HOUSE, EAST SIDE (figure 6.2)

the house. Evergreen species (such as *Rhododendron maximum*) are suggested to be placed at the edge of the yard. Alternative routing could divert visitor traffic away from historic boxwood nearby, see figure 6.2 for suggested routes. More permanent facilities are suggested to improve the visual quality of the amphitheater as well as terracing the seating area to mitigate existing erosion.

MAIN HOUSE, SOUTH SIDE (figure 6.2)

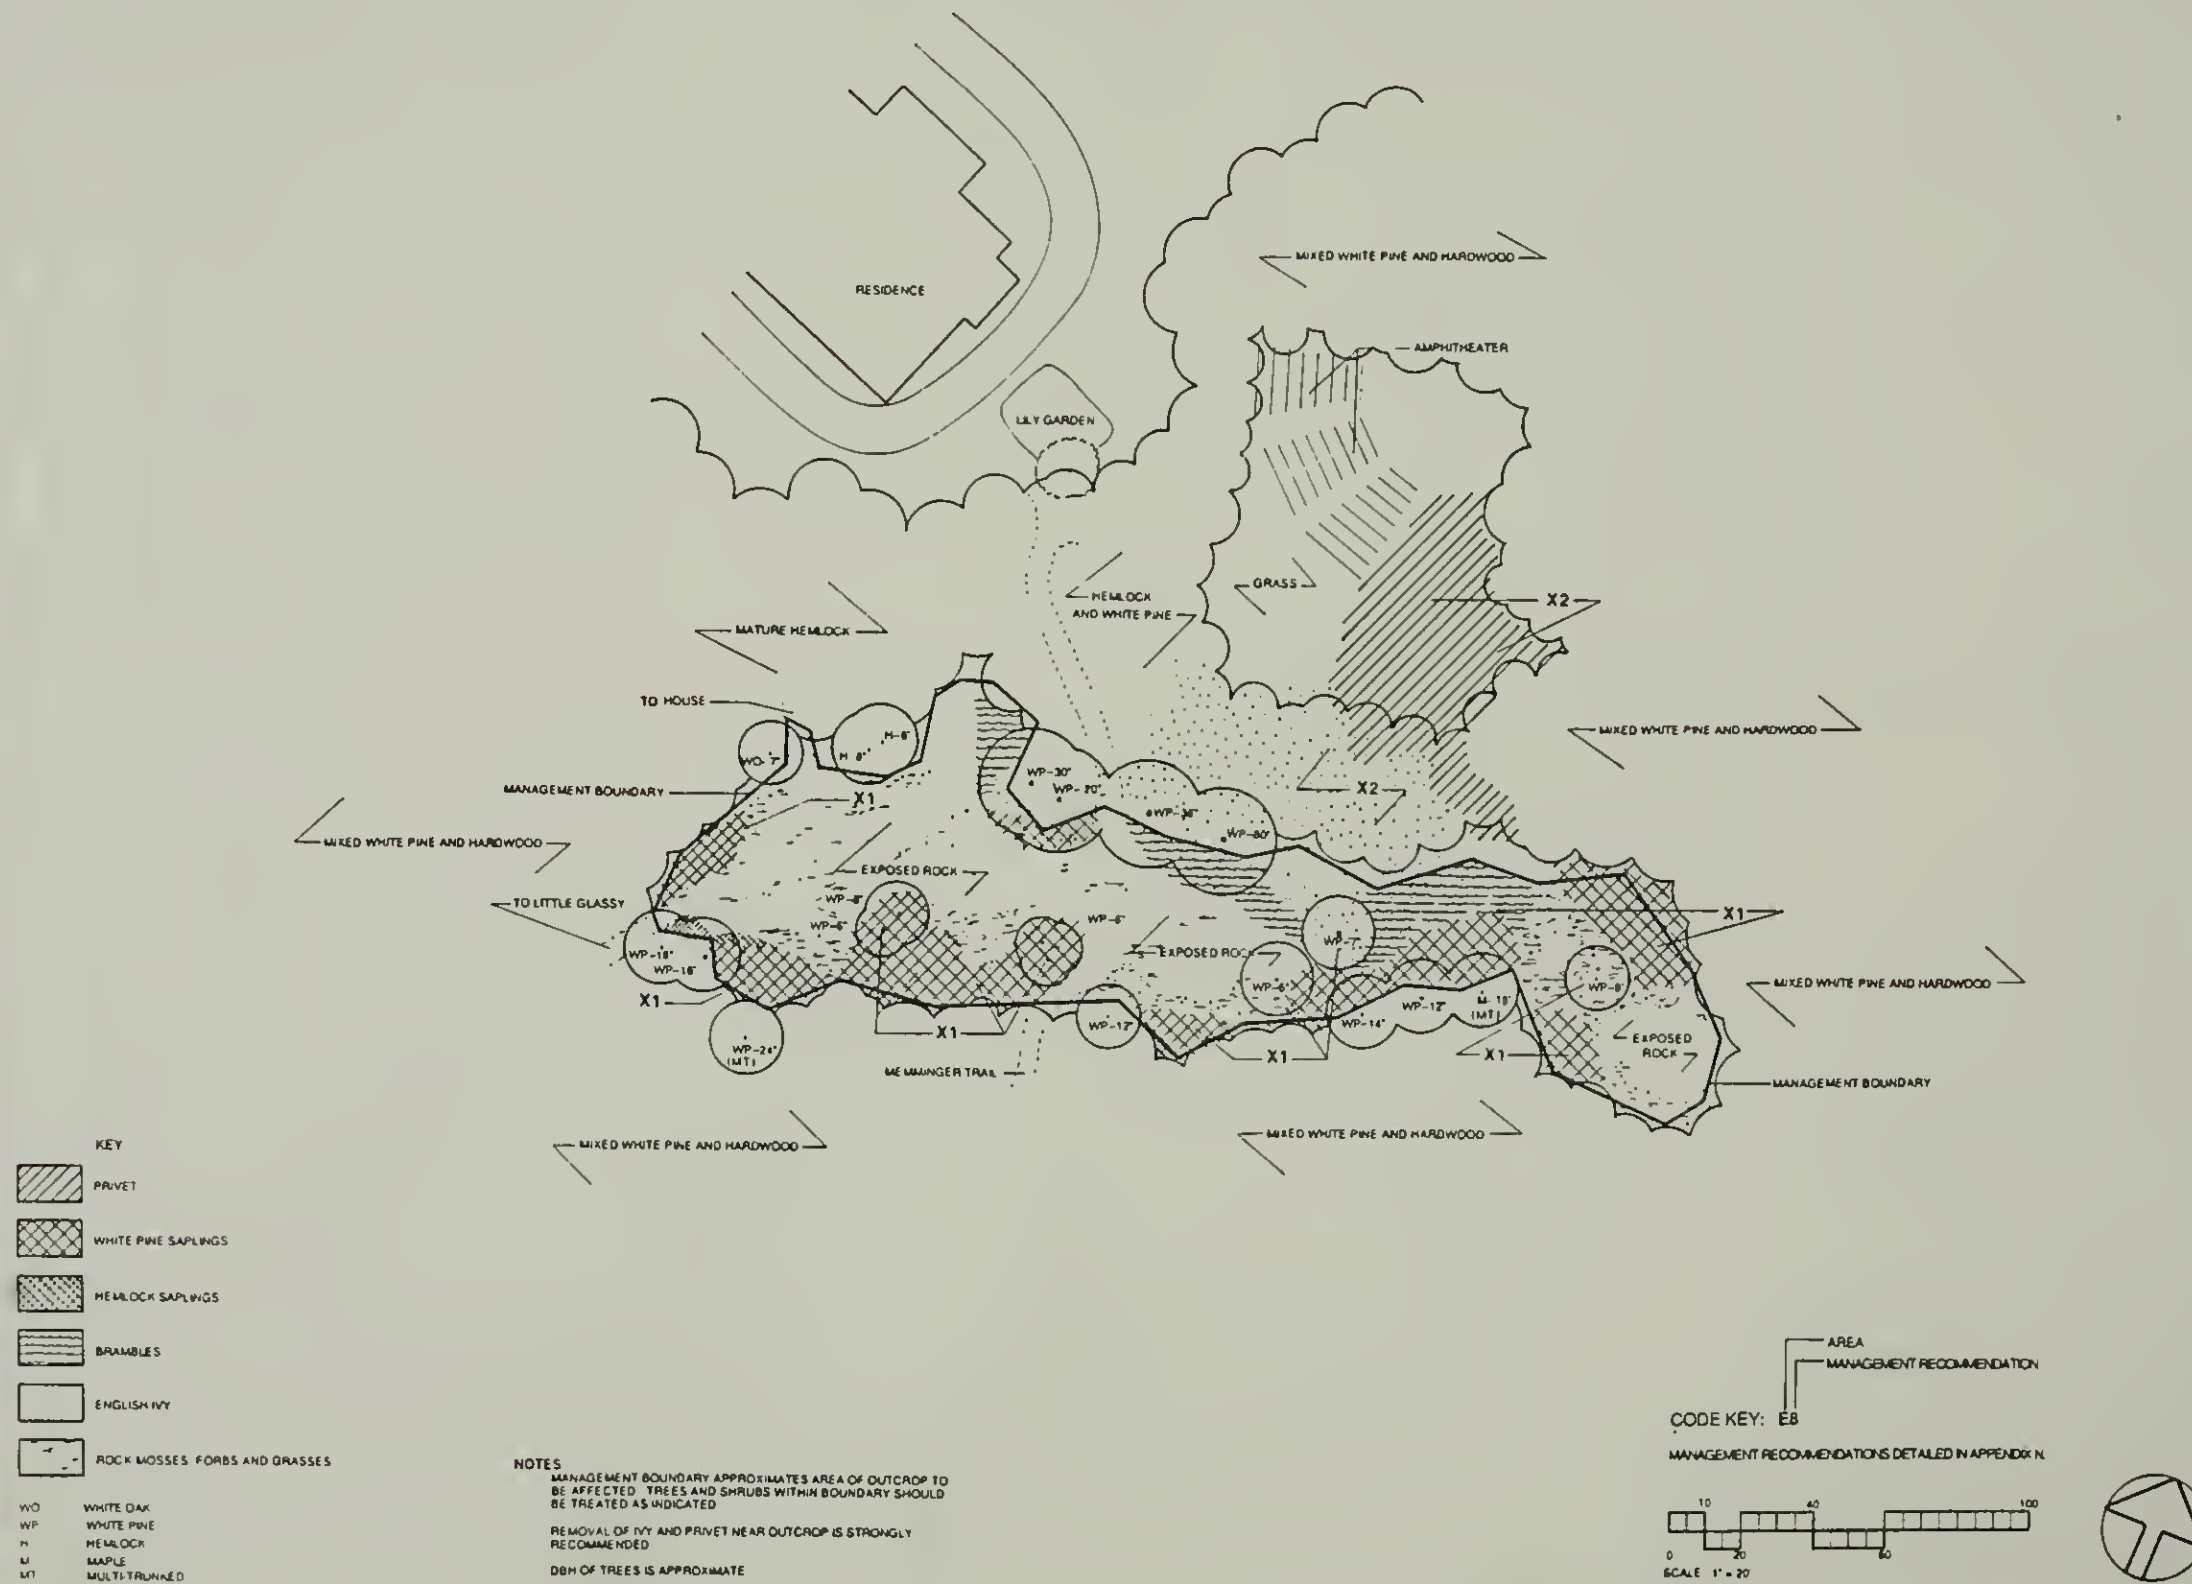
Fig. 6.11--Rock Outcrop--Management Recommendations

The rock outcrop behind the residence requires attention to prevent its disappearance. Figure 6.11 illustrates areas to be managed by periodically removing shrubs and saplings. Removal should occur every five to seven years within the indicated management boundary.
